SUPPLEMENTAL PROGRESS STATEMENT NO. 22

NOVEMBER 9, 1955

This progress statement reports the status of Job 2381 as of October 15, 1955.

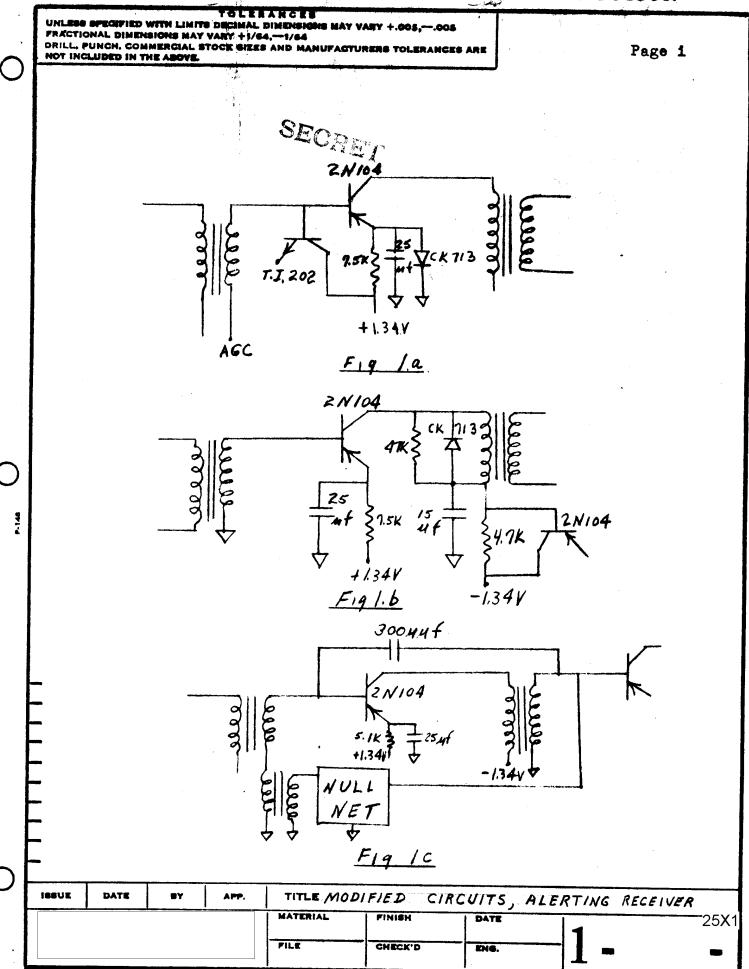
- the temperature was increased caused the AGC circuit to have insufficient control of the output of the broadband amplifier at +55°C. The increased current was supplied to the AGC clipping diode and to the base of the controlled stage in the form of increased I<sub>CO</sub> current. The clipping diode was removed and a transistor with a floating emitter was connected between the +1.3½ volt supply and the base of the AGC controlled transistor in such a manner that the transistor with the floating emitter is the source of I<sub>CO</sub> current for the AGC controlled transistor. The I<sub>CO</sub> current of both transistors varies in the same manner with temperature and the AGC output loading does not change appreciably with temperature. The circuit is shown in Fig. la.

- (c) At -30°C, the output of the broadband amplifier was reduced and the output vs. input characteristic exhibited a peak at about -50 dbm input, a dip at -40 dbm, and then decreased at higher input levels. Distortion of the output of the broadband amplifier increased at high power levels. The output of the null stages, which select the fundamental component of the broadband amplifier output, decreased to a value insufficient to drive the output stages and operate the sensitive relays.

Examination of this problem indicates a necessity for better control of the waveforms and amplitude in the first two stages

of the broadband amplifier. It is planned to use limiting in the first stage as well as the second stage and to attempt I co compensation similar to that described above, but introduced into the collector side of the transistor instead of into the base. See Fig. 1b.

(d) During the process of adjusting the null networks to the correct frequency and to have 20 db discrimination against off channel frequencies, considerable difficulty was encountered with oscillation of the null stages. Investigation of this problem revealed that in order to get 20 db of off channel discrimination, the null networks were being adjusted to give positive feedback at the null frequency. With this adjustment increases in the forward gain of the stage were causing oscillations. To correct this situation, the forward gain of the stage was increased by about 4 db and the null networks re-adjusted to have 20 db of off channel discrimination. The re-adjusted null networks then had negative feedback at the null frequency and hence changes in forward gain could not result in oscillations. The forward gain of the stage was increased by increasing the emitter current and removing the 20 K resistor across the primary of the output transformer. With this resistor removed, oscillations occurred at about 90 KC. A 300 µµf capacitor from the secondary of the output transformer back to the base of the transistor stopped this oscillation. These changes are indicated in Fig. 1c.

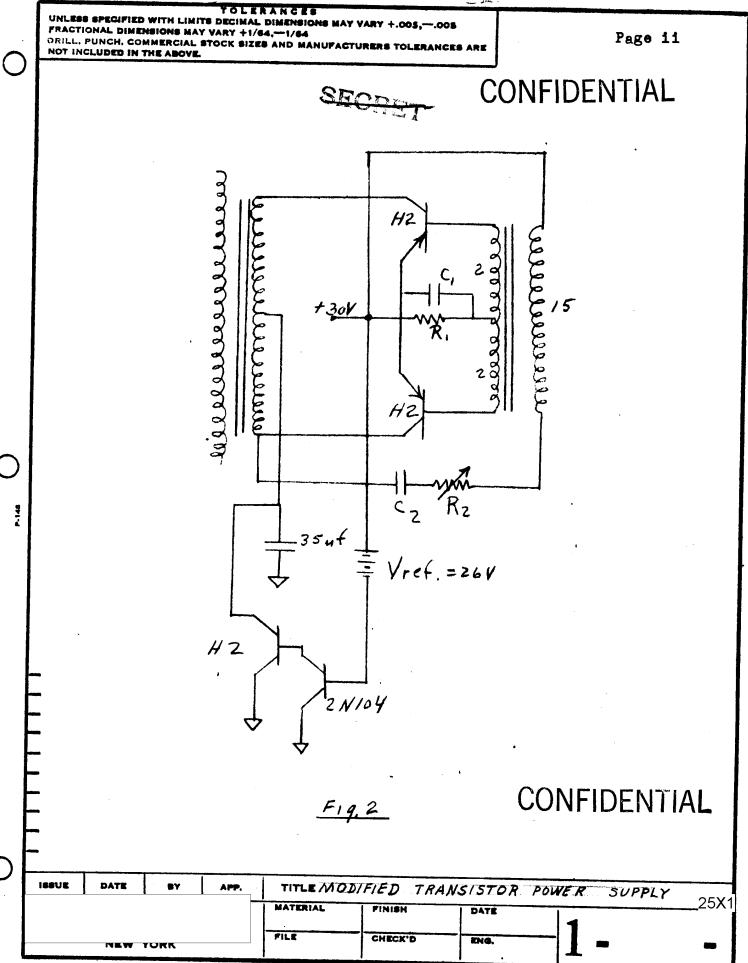
A check of the operation of the transistor power supply and transistor regulator at -27°C showed that neither of these circuits operated reliably at this temperature.

- (b) The transistor regulator also failed at -27°C. Since some changes were required, it was decided to change to what was considered a basically more sound circuit wherein the load is in the emitter circuit of the series regulating transistor. This requires that the series regulator be in the negative lead of the transistor power supply. An additional transistor is used to provide base current for the series regulating transistor to reduce the drain on the reference battery. The revised circuit is shown in Fig. 2.
